Workplace Health & Safety Report

Property Name: Reef Terraces
CTS No.: 888
Address: 121 Port Douglas Road, Port Douglas, QLD, 4877

Date of Audit: 12 December 2022
Prepared By: Bruce Grimley

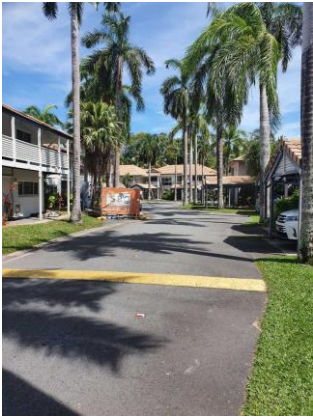
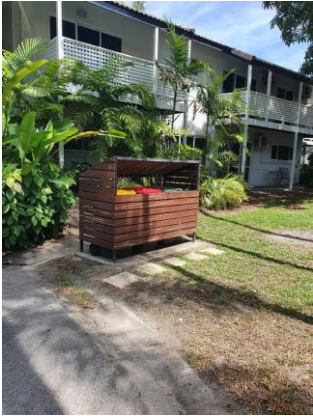
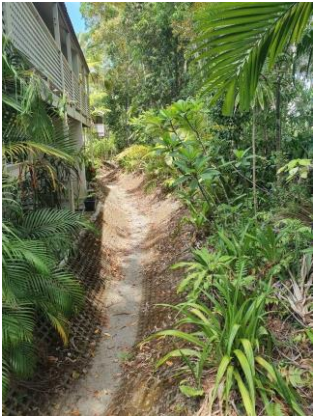
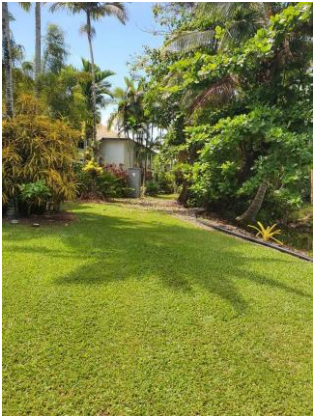
1. General – Housekeeping, Common Areas Indoors and Outdoors				
Area Inspected	Yes/No/NA	Photo/Issue	Risk Ranking	Recommendation
1.1 - Are common areas free from rubbish and obstructions?	Yes

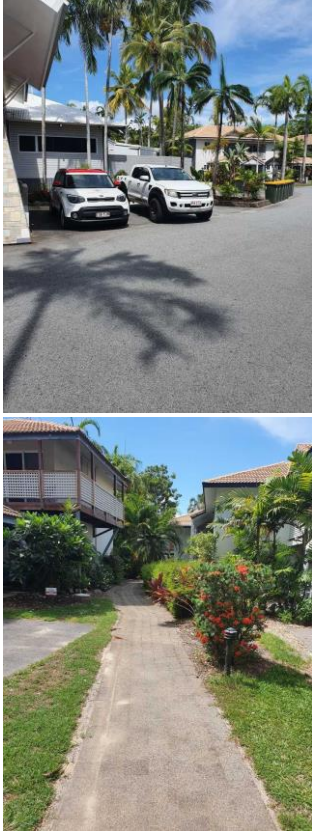
1. General – Housekeeping, Common Areas Indoors and Outdoors				
Area Inspected	Yes/No/NA	Photo/Issue	Risk Ranking	Recommendation
1.2 - Are pathways, driveways and parking areas – unobstructed and clearly defined where possible? No observed trip hazards?	Yes

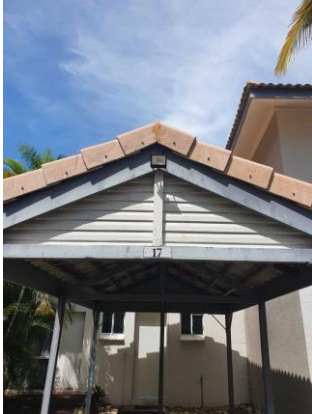
1.3 - Pathways and Driveways are adequately light for safe travel? (Visual only)	Yes

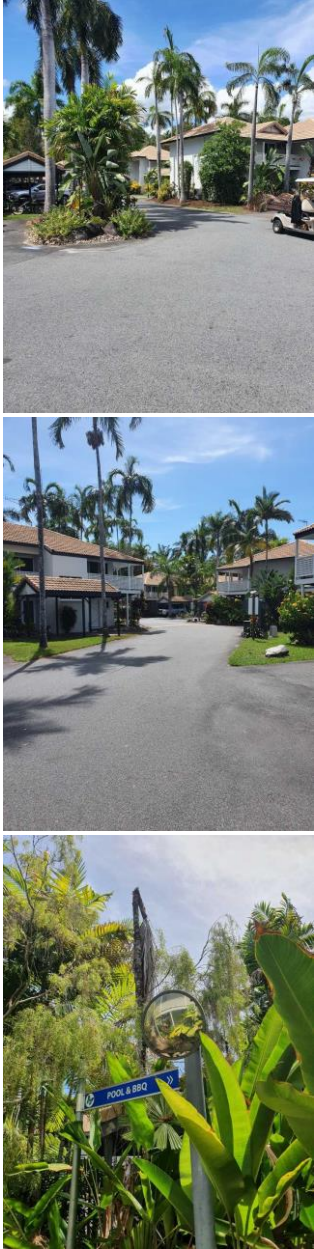
1.5 - Pathways and Walkways – Are all observed walkways non-slip with no fall hazard? (visual inspection only)	No	Pavers at multiple locations in pool area have moved over time	Moderate	It is recommended relaying pavers that have moved due to subsidence and tree roots

1. General – Housekeeping, Common Areas (Indoor and Outdoor)			
Area Inspected	Photo/Issue	Risk Ranking	Recommendation
1.5 - Pathways and Walkways – Are all observed walkways non-slip with no fall hazard? (visual inspection only)	Pavers at multiple locations in pool area have moved over time	Moderate	It is recommended relaying pavers that have moved due to subsidence and tree roots

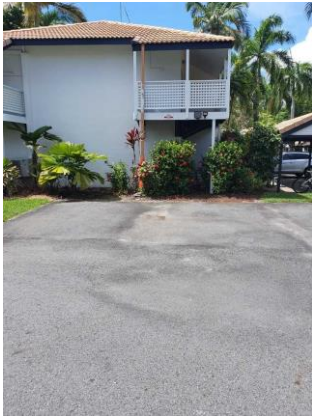
1.6 - Is car park line marking clearly visible?	No	<p>No line marking installed</p>

Low	It is recommended that line marking be done or redone to ensure clear delineation between parking bays or ensure walkways are clearly defined.
1.7 - Are gardens free of falling or protruding objects that could cause injury?	No	<p>A number of mango trees are located throughout the complex and this time of year fruit is present and can fall</p>	Moderate	It is recommended signs be installed in the area under the trees to warn residents of the risk

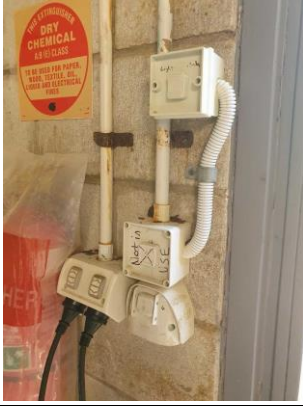
2. Electrical – Switchboards and Safety Installations				
Area Inspected	Yes/No/NA	Photo/Issue	Risk Ranking	Recommendation
2.1 - Are all observed plugs, sockets, switches unbroken and working?	Yes

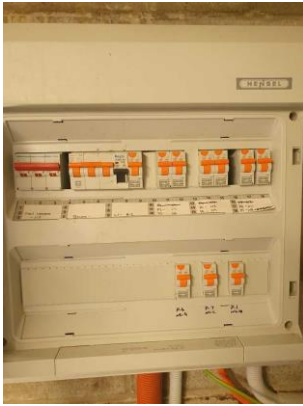
2.3 - Are all observed portable electrical items tested and tagged?	NA			
2.4 - Have common / community Safety Switches/RCD's been inspected and records available?	No	No records sighted

Moderate	It is recommended that the Body Corporate ensure that all common property safety switches (Residual Circuit Device) are tested by a person on-site every 6 months and also every two years by an authorised electrical contractor. Records of the testing should be kept. Refer Electrical Safety Regulations 2013

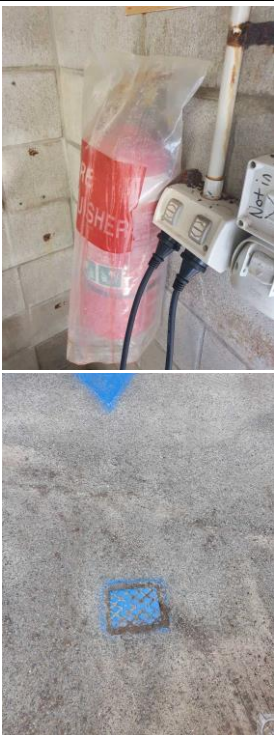
6. Fire Control				
Not applicable to Class 1a buildings.				
Area Inspected	Yes/No/NA	Photo/Issue	Risk Ranking	Recommendation
6.1 - Are prescribed fire safety installations in place and in date and clear of obstruction? (Sample, including tag or log books, including in-ground hydrants)	Yes

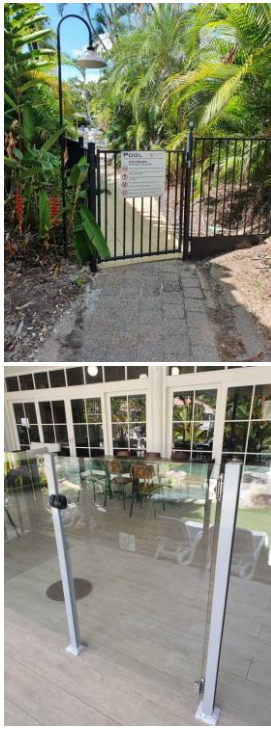
8.2 - Does the pool fence and gate conform to: Height < 1200mm, or 1800mm if boundary fence Gap < 100mm And gate self closes – check hinges for climbing point	Yes

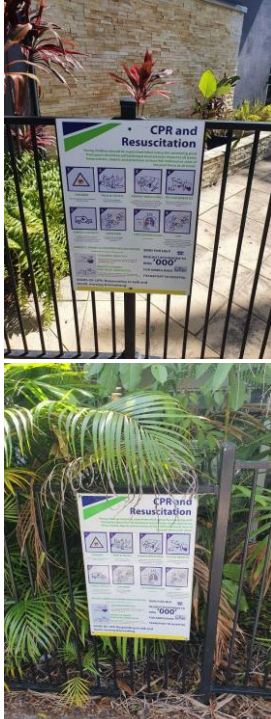
8.3 - Are Cardiopulmonary Resuscitation (CPR) signs in place – (current as from December 2010 and, for pools over 50m, 1 either end).	Yes

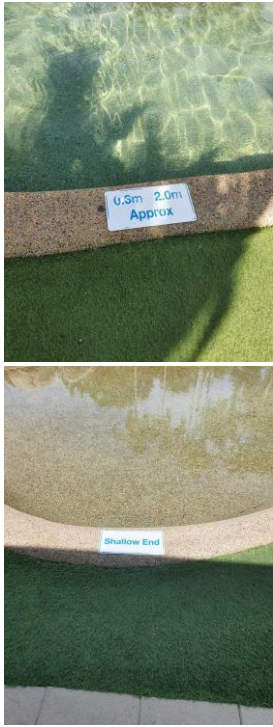
8. Pool Area				
Area Inspected	Yes/No/NA	Photo/Issue	Risk Ranking	Recommendation
8.4 - Are depth markers in place and visible from 20m? (Must be there visible to swimmers).	Yes

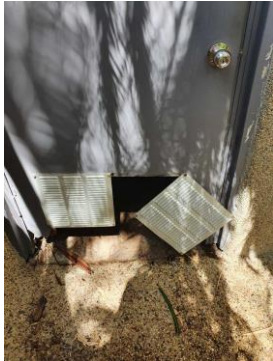
8.6 - Are Deep Water signs in place? (Must have for depths of 1.8m or more)	NA			
8.7 - Is the pool pump shed in good condition Locked / Signed?	No	<p>Door showing severe signs of weather damage</p>

Moderate	It is recommended that the Body Corporate repair the pool pump shed door.

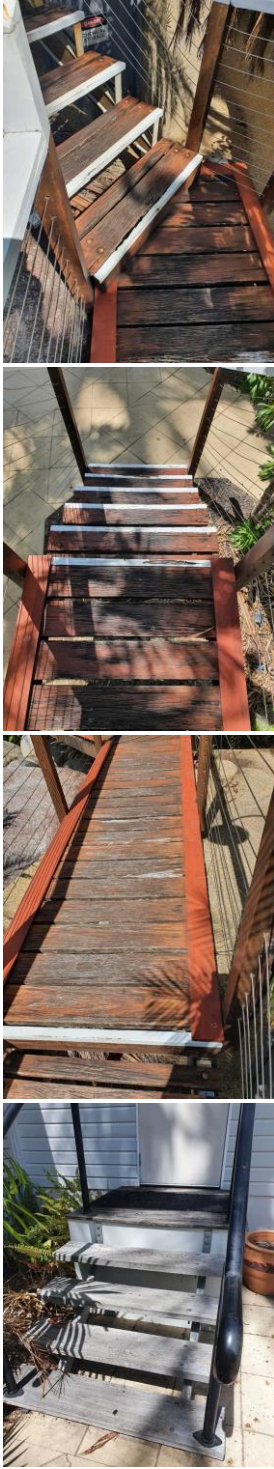
9. General Building Structure				
Area Inspected	Yes/No/NA	Photo/Issue	Risk Ranking	Recommendation
9.1 - Are stairs and stair railings in good order? (No sharp edges, timber rotten, step edge not damaged etc)	No	<p>Timber stairs and walkway over pool water fall are showing severe weather damage</p>

High	It is recommended that all stairs and walkways be repaired to ensure safe travel for all persons that access these areas.
9.2 – Roof top working at heights. Free from any issues, (have anchor points fitted, restricted access or	Yes

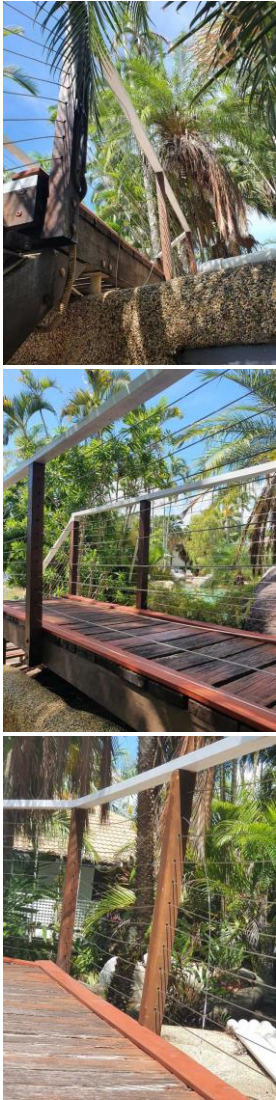
9. General Building Structure				
Area Inspected	Yes/No/NA	Photo/Issue	Risk Ranking	Recommendation
balustrades fitted around edge?)				
9.3 - If roof top anchor points are installed, have they been inspected, and a record observed?	NA			
9.4 - Do Balustrades/Railings appear to be undamaged and safe to use? (Observation from ground level only).	No	<p>Wire balustrade on walkway over pool waterfall damaged and loose</p>

High	It is recommended that all balustrades be secured and compliant to ensure safe for all persons when using these areas.

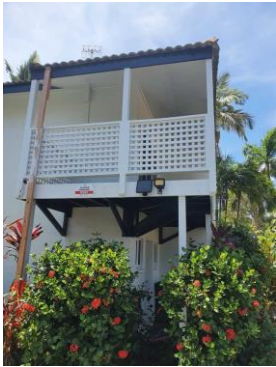
9.6 - Are all ladders in good condition? (Industrial rated preferred -150kg)	NA			
9.7 - Does the current balustrade comply with the following:- <ul style="list-style-type: none"> • Height > 1000mm • Spacing between the elements < 125mm • Bottom base < 125mm Note:- Current Building Code Australia requirements	Yes

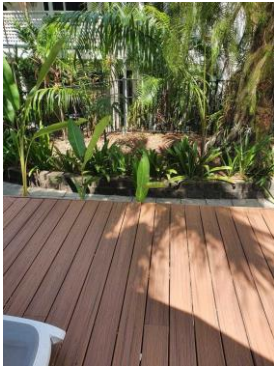
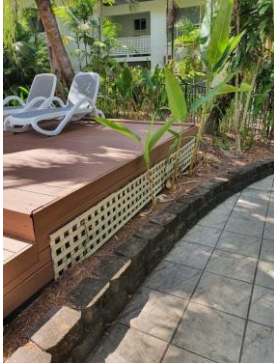
9.9 – There are no fall risks where a significant injury may occur if a person’s falls?	No	<p>No barrier installed on deck in pool area</p>

Moderate	It is recommended that all fall risk areas where there is a risk of injury be protected by a barrier to prevent or reduce the risk of a person falling.
